## **S19 Flood Investigation**

Storm Kathleen - Littlehampton, April 2024

Storm Kathleen, April 2024

**REPORT (VERSION1) PUBLIC**

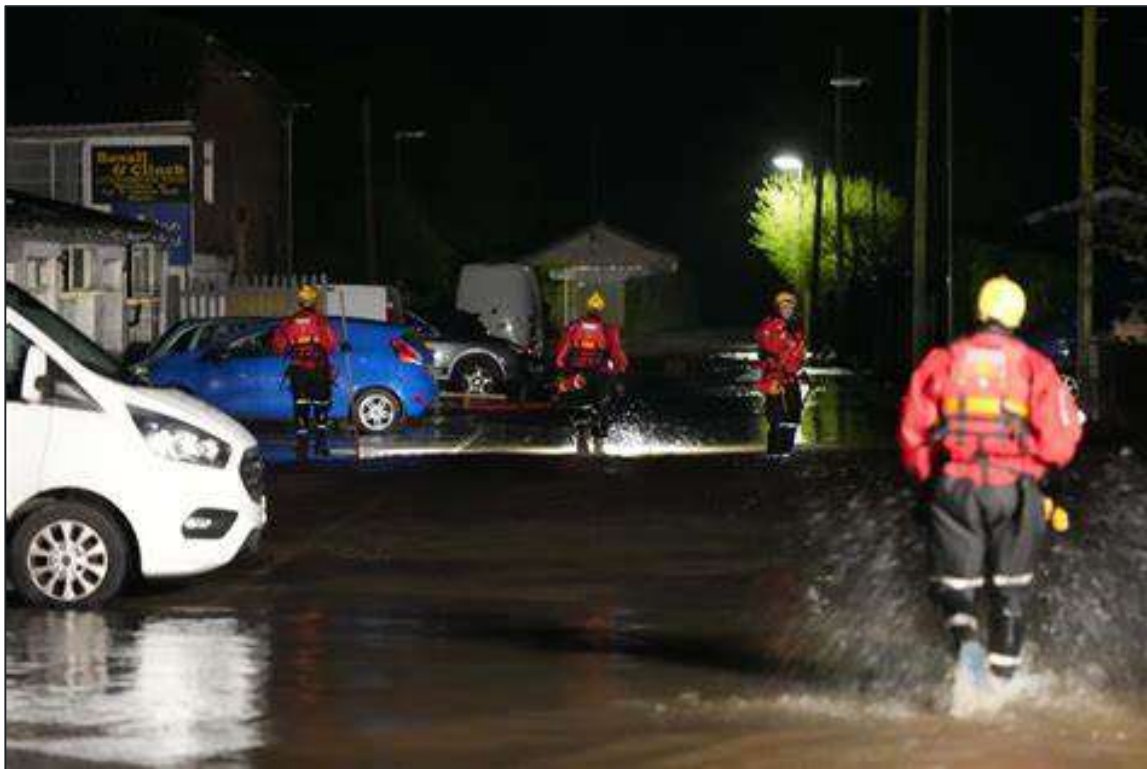
**Figure 4-2 - Flooding at Rope Walk**

- 4.3.6. An emergency evacuation was carried out through the night by the fire brigade and other emergency services (refer to Figure 4-2). Due to flooding on Ferry Road, residents of Rope Walk were evacuated using the footbridge that crosses the River Arun. This was complicated due to nighttime conditions and the lack of light after a substation at the end of Rope Walk was flooded out. Flooding also put an SSE pumping station in Rope Walk out of service.

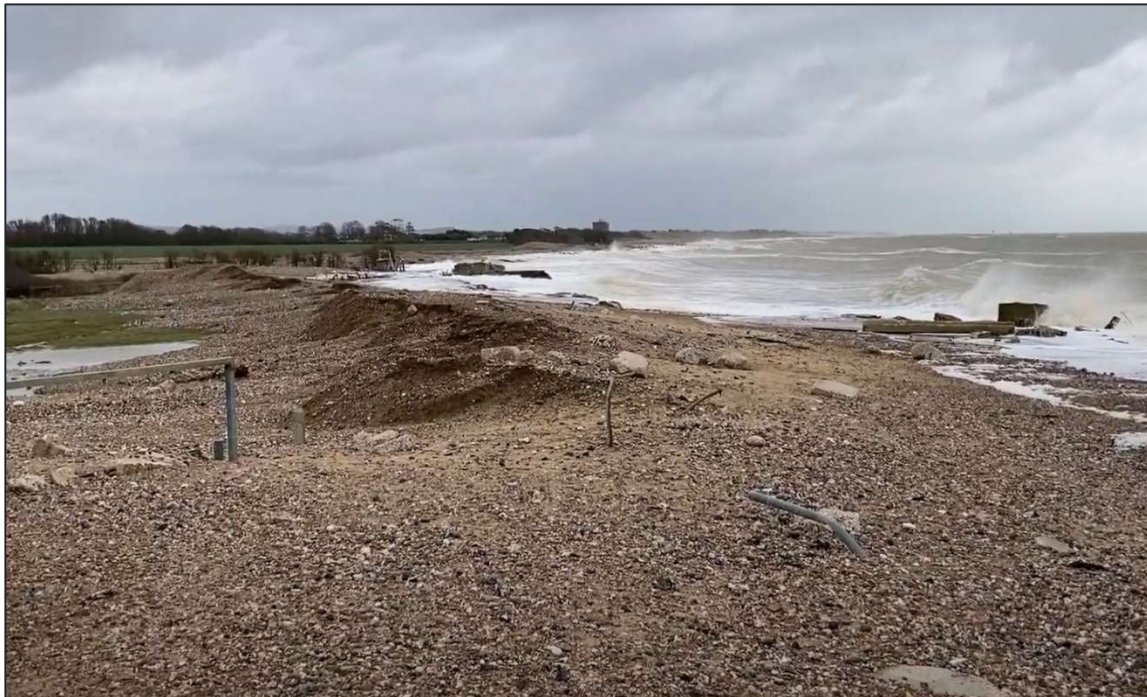
**Figure 5-1 - Eroded Coastal Defences at Climping Beach (taken 9th April 2024)**

- 5.4.2. During WSP's site visit to Littlehampton, it was reported that shingle beach coastal defences at Climping Beach have degraded over recent years (refer to Figure 5-1). Furthermore, old defences were deemed unsafe and were removed in recent years. These included timber groynes and concrete structures which originally formed part of the car park. Residents believe there has been an increase in flooding since.

- 5.4.3. The design standard for the current Climping Beach defences provides an approximate 1 in 20 to 1 in 50 level of protection. Consultation with the Environment Agency has confirmed that the beach is managed in accordance with the Arun to Pagham strategy which recommends a reactive patch & repair approach to maintenance of the beach and structures. Prior to Storm Kathleen and Storm Pierrick, 250m<sup>3</sup> of shingle was recycled in December 2023.

- 5.4.4. During the 2024 flood event, the weakened coastal defences were overtopped and seawater flooded into agricultural land behind. This caused backing up of water in the ditch and rife system which in turn contributed to the flooding to Rope Walk and Ferry Road.

- 5.4.5. The Environment Agency confirmed that immediately prior to Storm Kathleen and Storm Pierrick, most of the beach was a 'condition 3 – fair', with the section to the west of WSP's study area being a 'condition 4 – poor'. The Agency's inspector commented that the beach berm, *"is uneven with movement of shingle due to wave attack and vehicle movement creating deep ruts. Crest is very narrow and uneven, with loss of crest suggesting movement of shingle by waves"*. The Environment Agency also remarked that, *"the defence is not uniform in condition along its length due to the need for access to be allowed at the Bread Lane byway and access track at Mill Lane. The standard of protection along the frontage ranged between 1 in 50 to 1 in 1 at the gaps in the defence"* prior to the flood event.

- 7.3.1. It is noted that following Storm Kathleen, the Environment Agency replenished shingle at Climping Beach. Therefore, one recommendation of this report is the continued inspection and maintenance of the Environment Agency's coastal defences at Climping Beach to maintain an acceptable level of protection to Rope Walk and Ferry Road from coastal flooding. This area of frontage could be highlighted as a priority, and arrangements could be made for pre-emptive inspections on receipt of forecasts of heavy rain or tidal surges. This will also prevent the infilling of the ditch that runs behind the coastal defences at Climping Beach from shingle that has been washed over during storms.

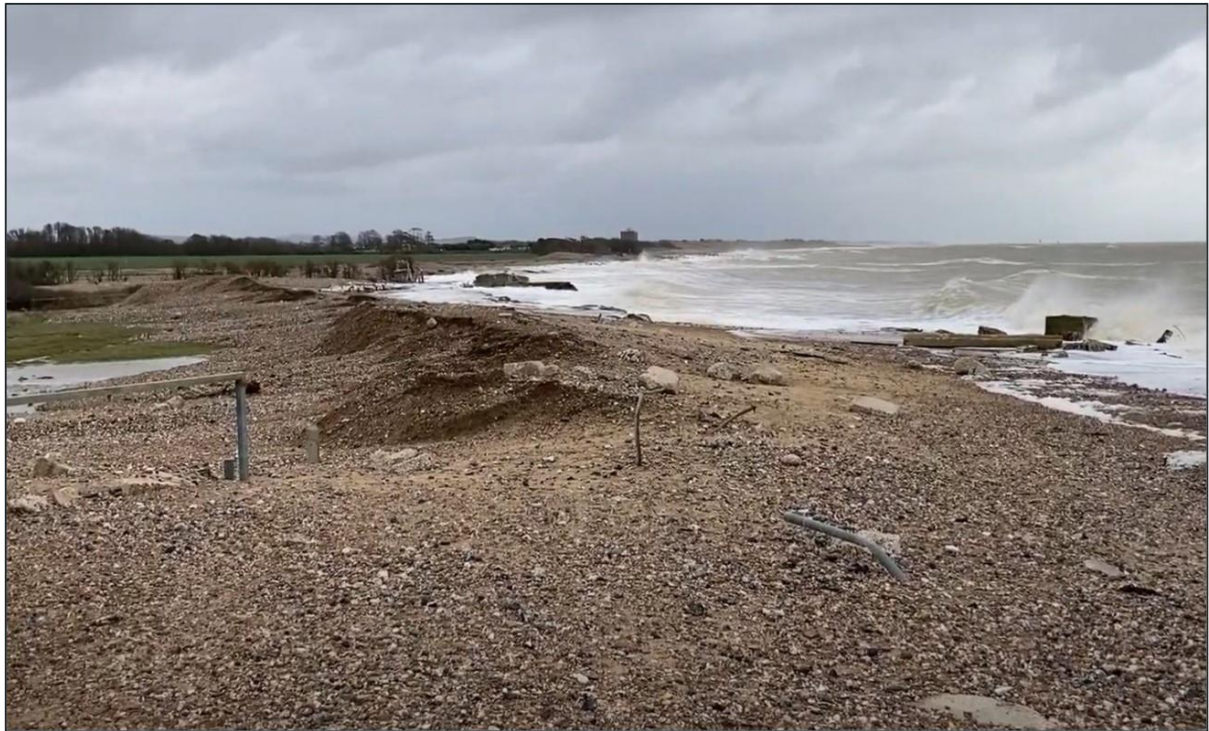
Photo 1 – Climping Beach Seafront taken following Storm Kathleen (Source: <https://youtu.be/uVf-8vjIJ4c>)

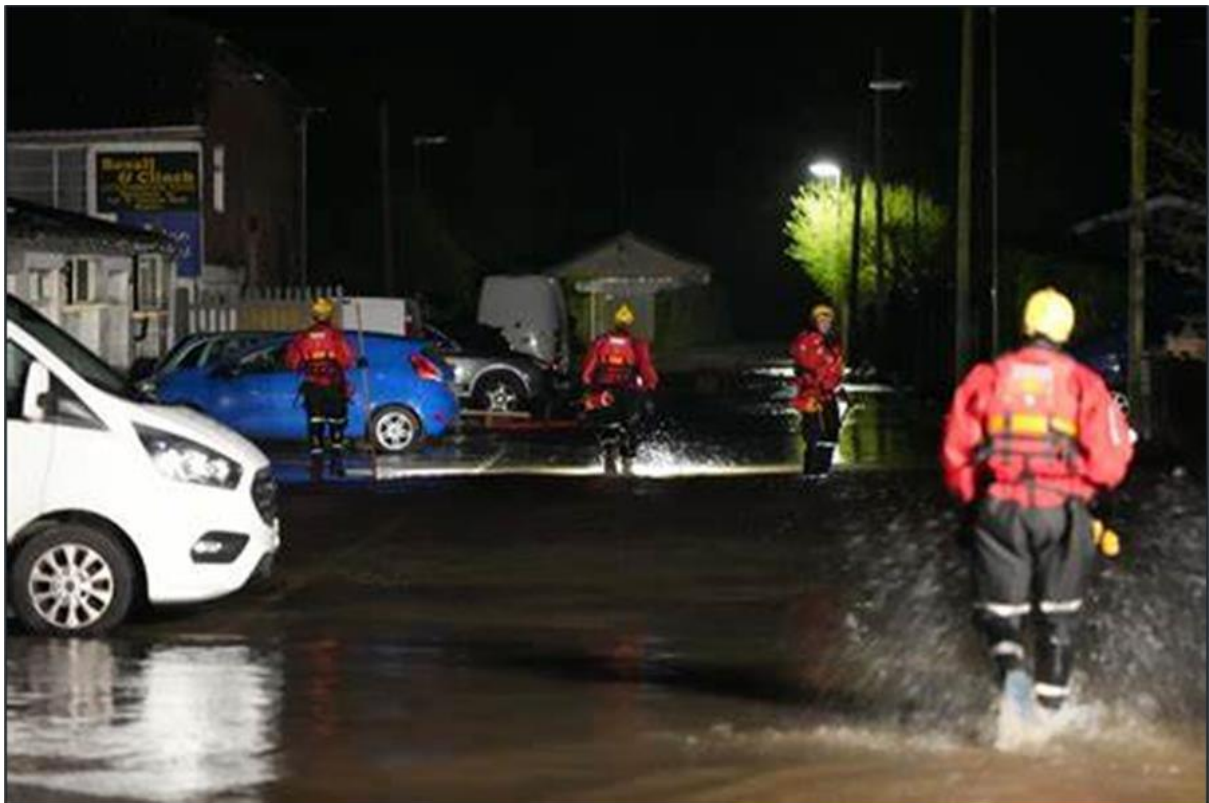
Photo 2 – Rope Walk during the April 2024 flood event (Source: <https://www.sussexexpress.co.uk/news/storm-kathleen-flooding-chaos-in-sussex-after-river-arun-bursts-its-banks-and-holiday-park-evacuated-4584019>)

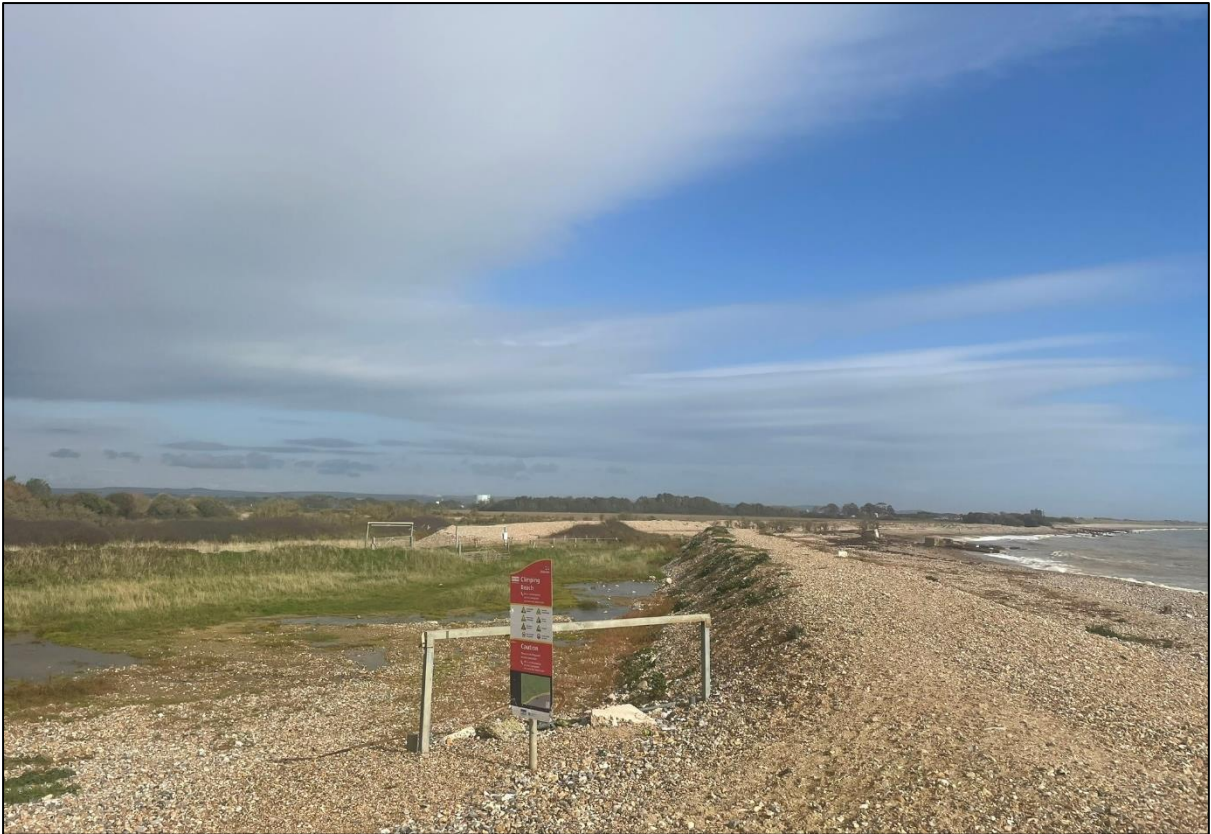
Photo 3 – Climping Beach Seafront taken 16/10/2024

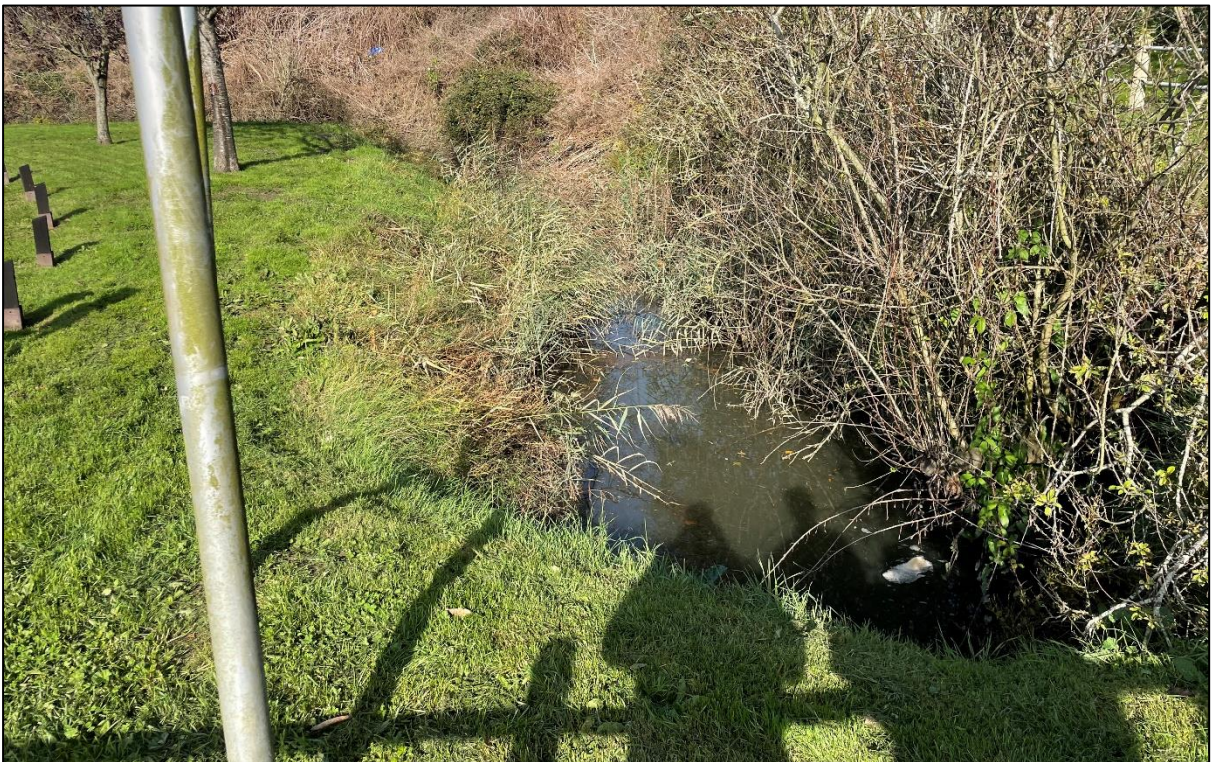
Photo 4 – Rope Walk Ditch taken 16/10/2024

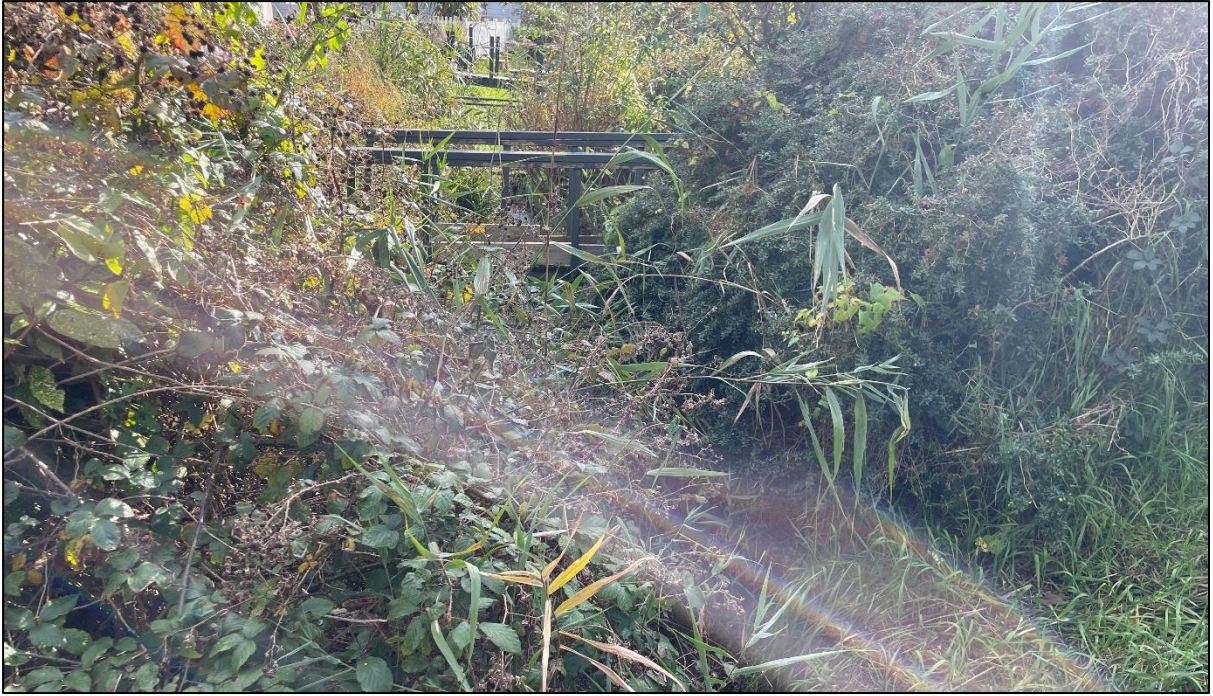
Photo 5 – Rope Walk Ditch taken 16/10/2024

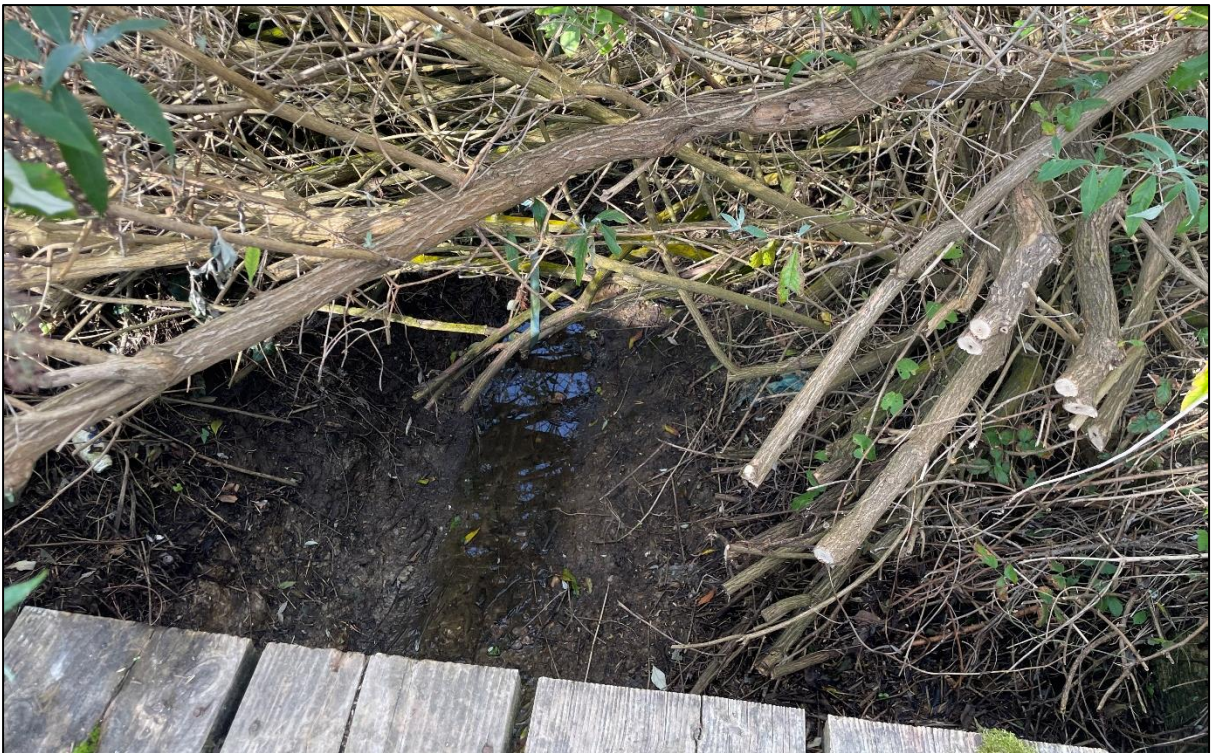
Photo 6 – Rope Walk Ditch taken 16/10/2024

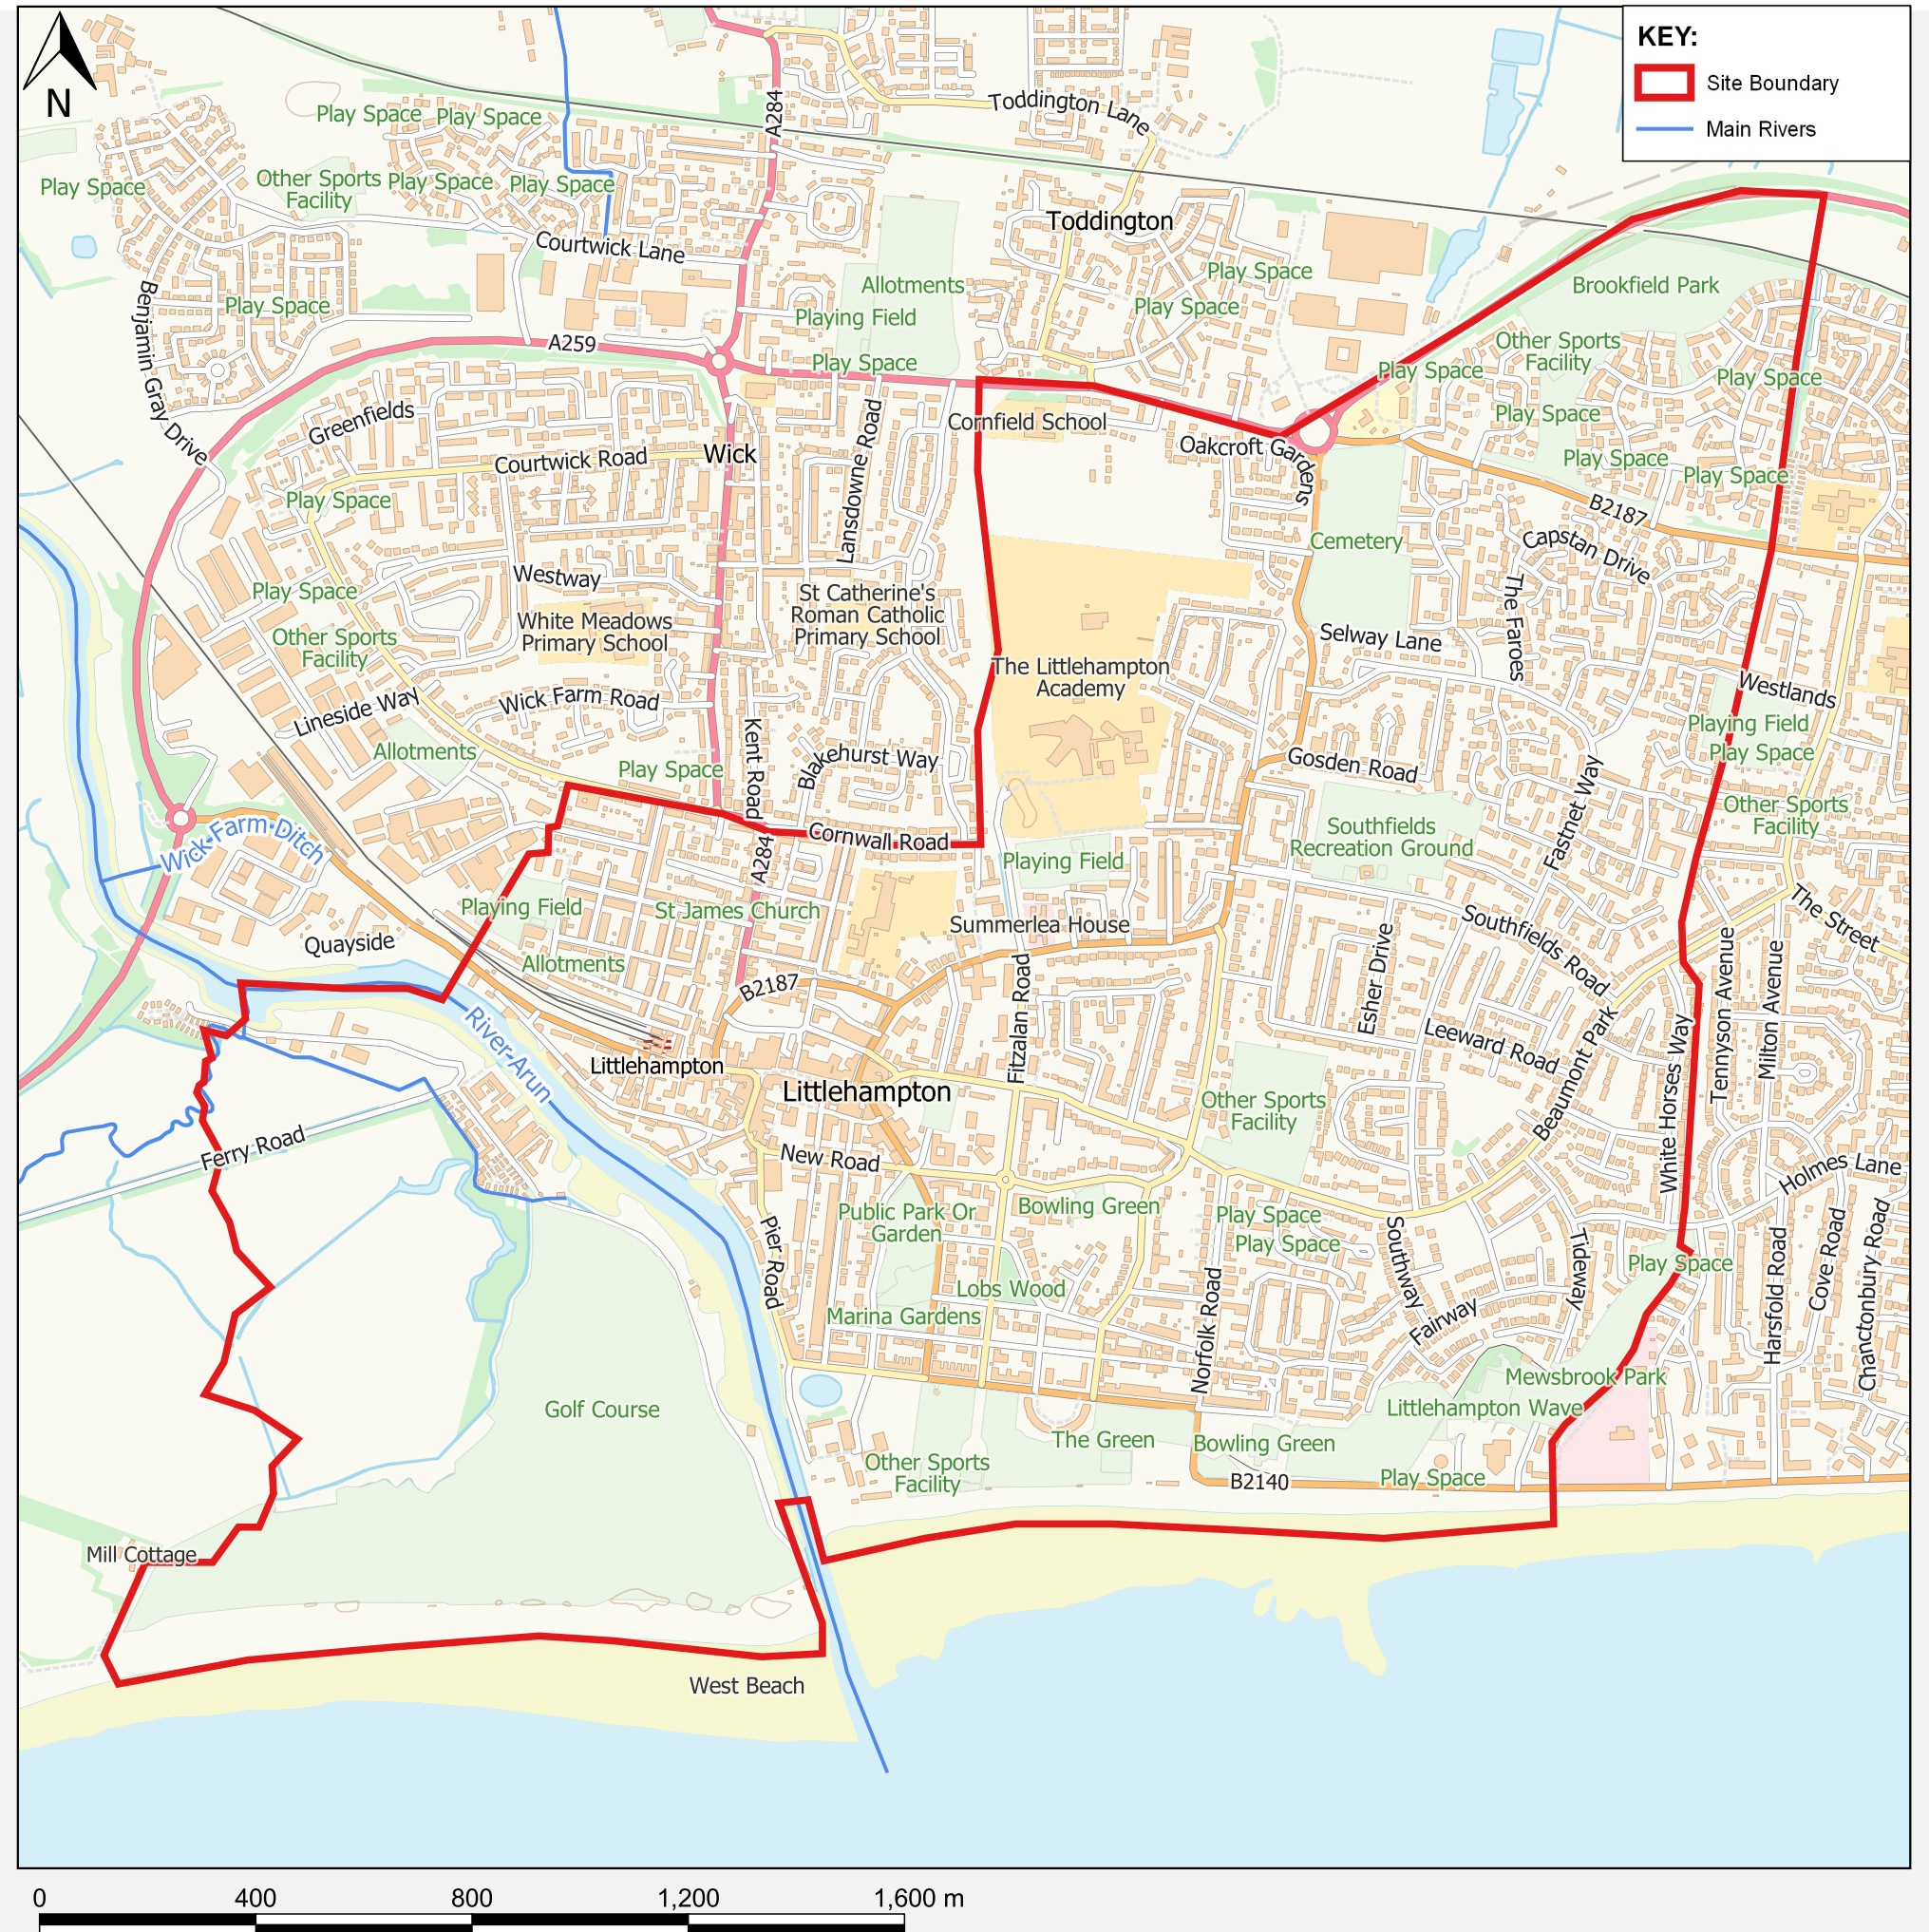
# Flood Map for Planning

Flood zone maps are modelled using local and national river and sea data. This information provides an indication of the likelihood of flooding and is intended for planning use only.

- **Flood Zone 1** - Land having a less than 1 in 1,000 annual probability (0.1% AEP) of river or sea flooding - all land outside Zones 2 and 3).
- **Flood Zone 2** - Land having between a 1 in 100 and 1 in 1,000 annual probability (0.1% - 1.0% AEP) of river flooding; or land having between a 1 in 200 and 1 in 1,000 annual probability (0.1% - 0.5% AEP) of sea flooding.
- **Flood Zone 3** - Land having a 1 in 100 or greater annual probability (>1.0% AEP) of river flooding; or Land having a 1 in 200 or greater annual probability (>0.5% AEP) of sea flooding.

**Reduction in Risk of Flooding from Rivers and Sea due to Defences** -Reduction in Risk of Flooding from Rivers and Sea due to Defences is a spatial dataset that indicates where areas have reduced flood risk from rivers and sea due to the presence of flood defences. The dataset has been created to help initiate conversations about the impact our flood defences have on the risk of flooding from the rivers and sea, and as a prompt to find out more about the flood defences in a particular area of interest. It does not replace any local, more detailed information.

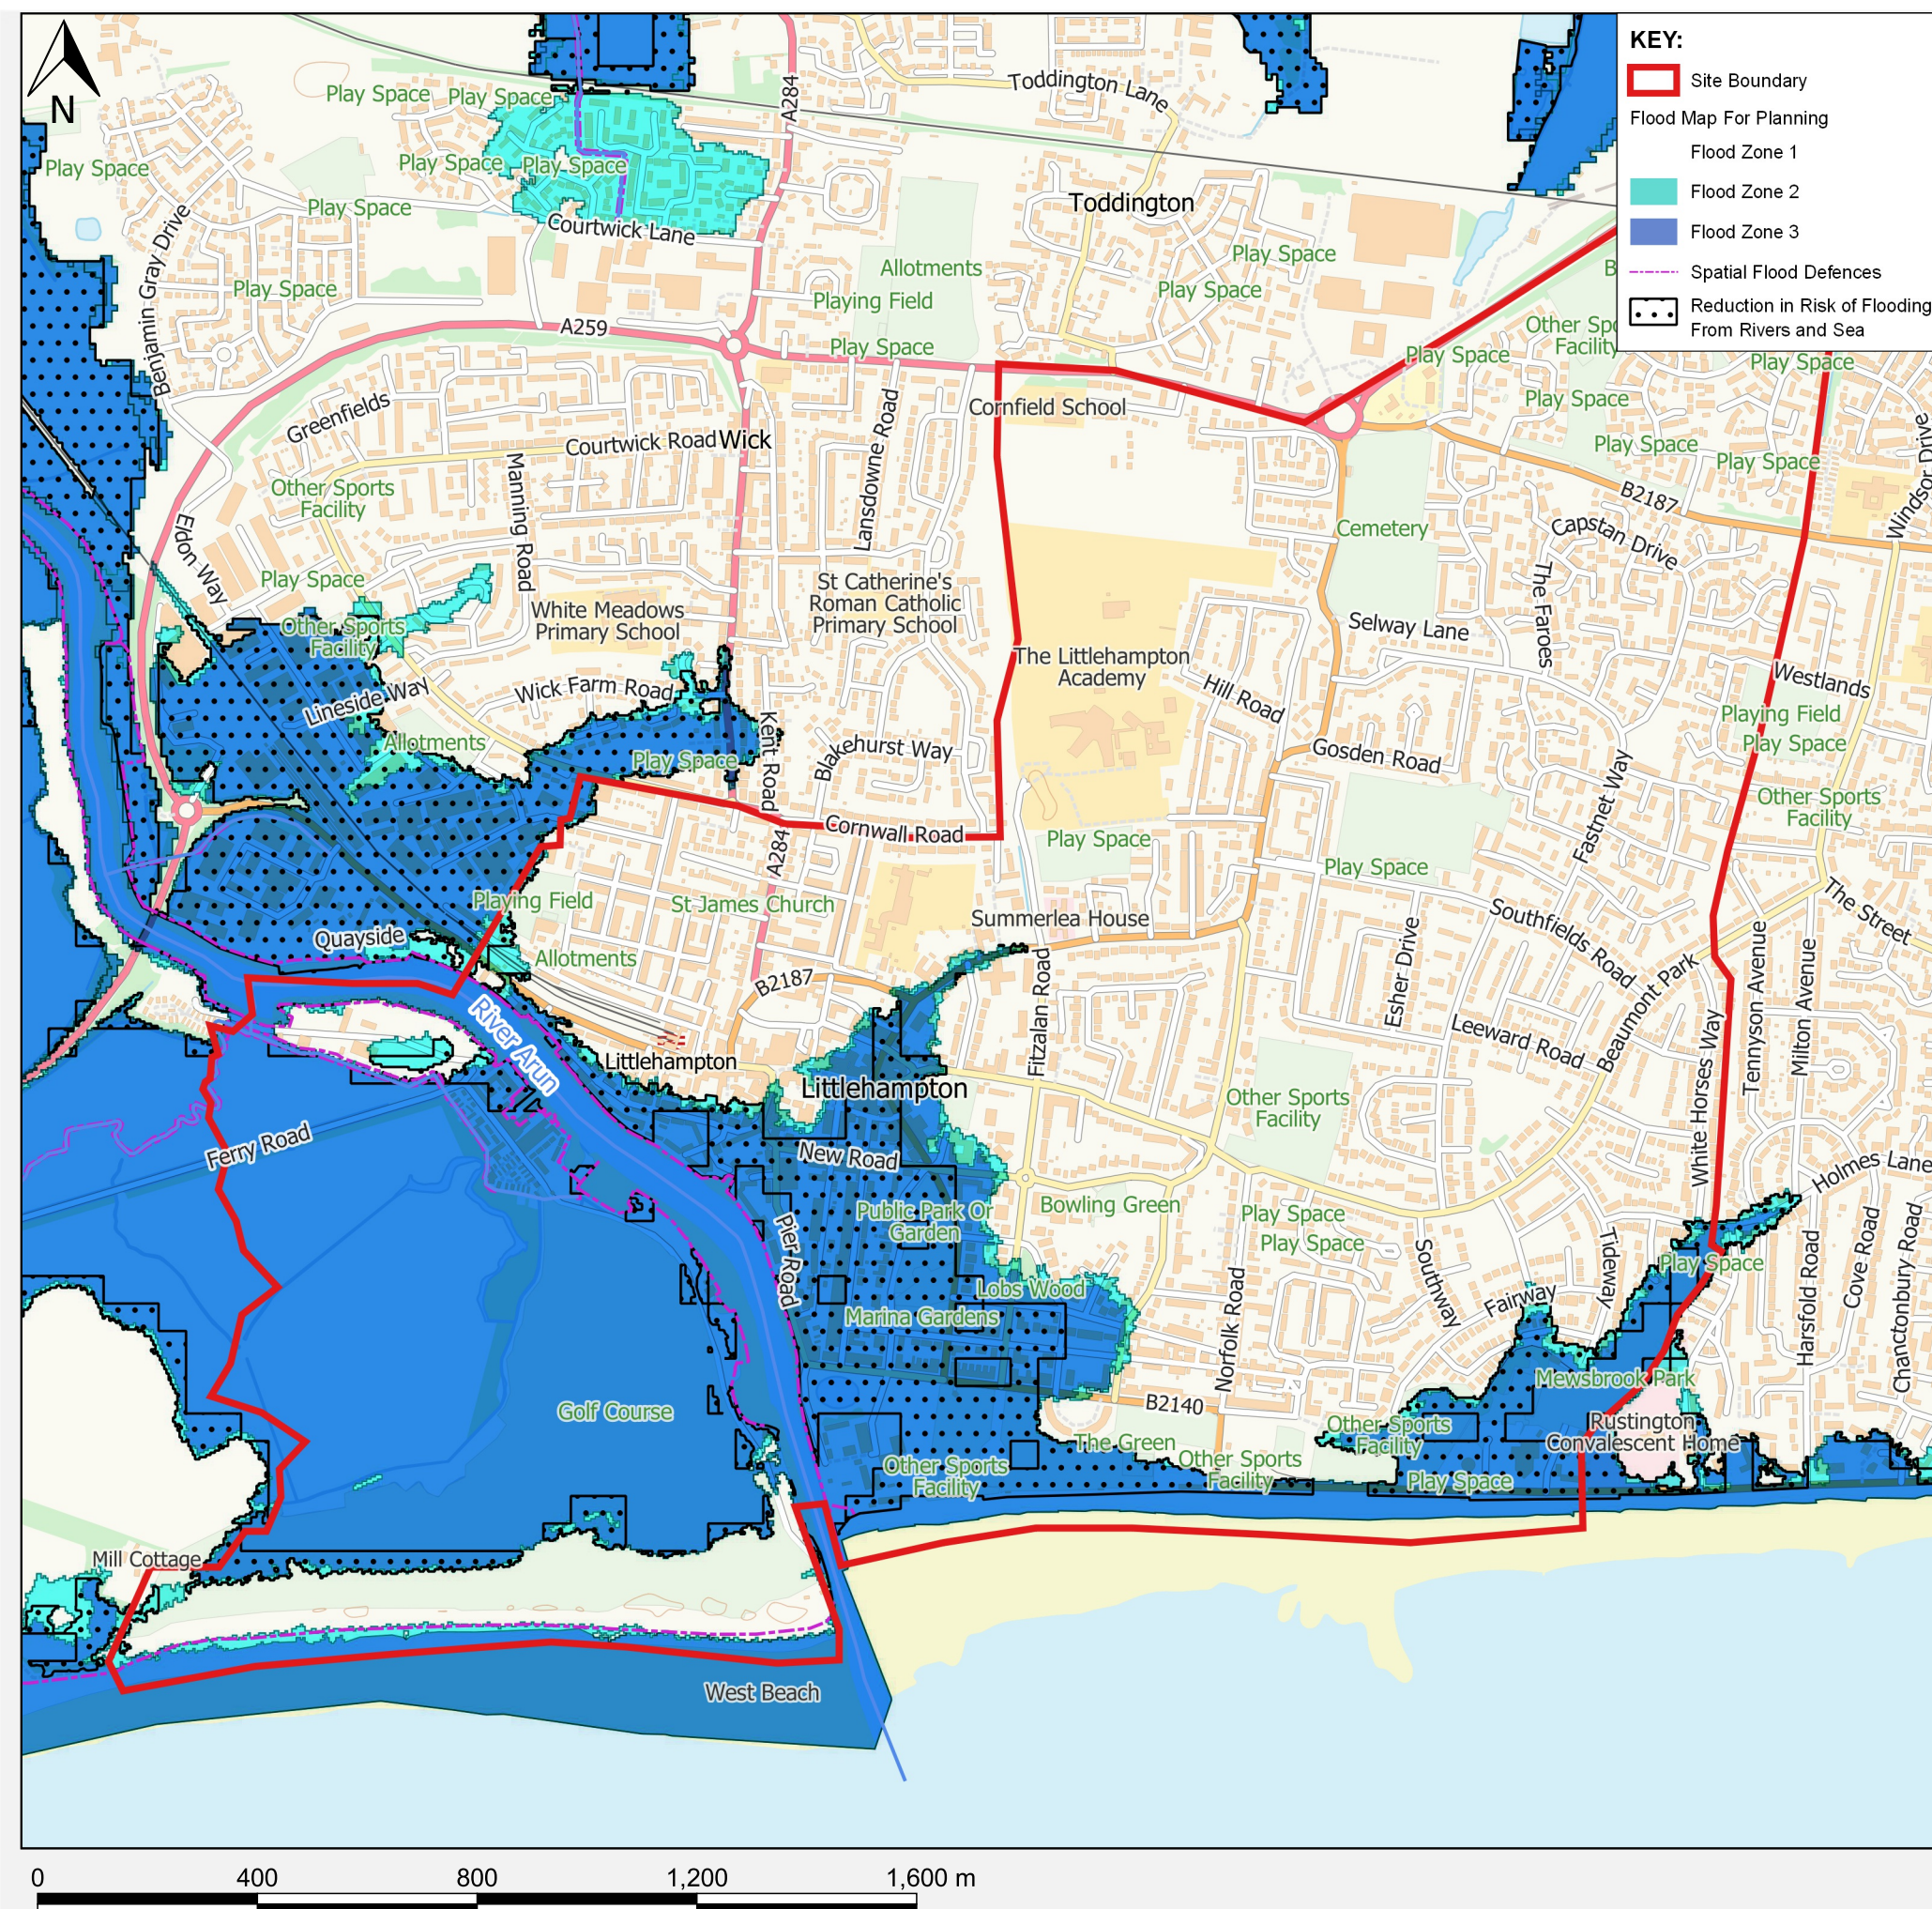
## Risk of Flooding from Rivers and Sea

This map takes into account the effect of any flood defences in the area. These defences reduce but do not completely stop the chance of flooding as they can be overtopped, or fail.

**Low Risk** - Land having between a 1 in 100 and a 1 in 1000 annual probability (0.1% - 1.0%) of flooding from rivers or the sea.

**Very Low Risk** - Land having a less than 1 in 1,000 annual probability (0.1% AEP) of flooding from rivers or the sea.

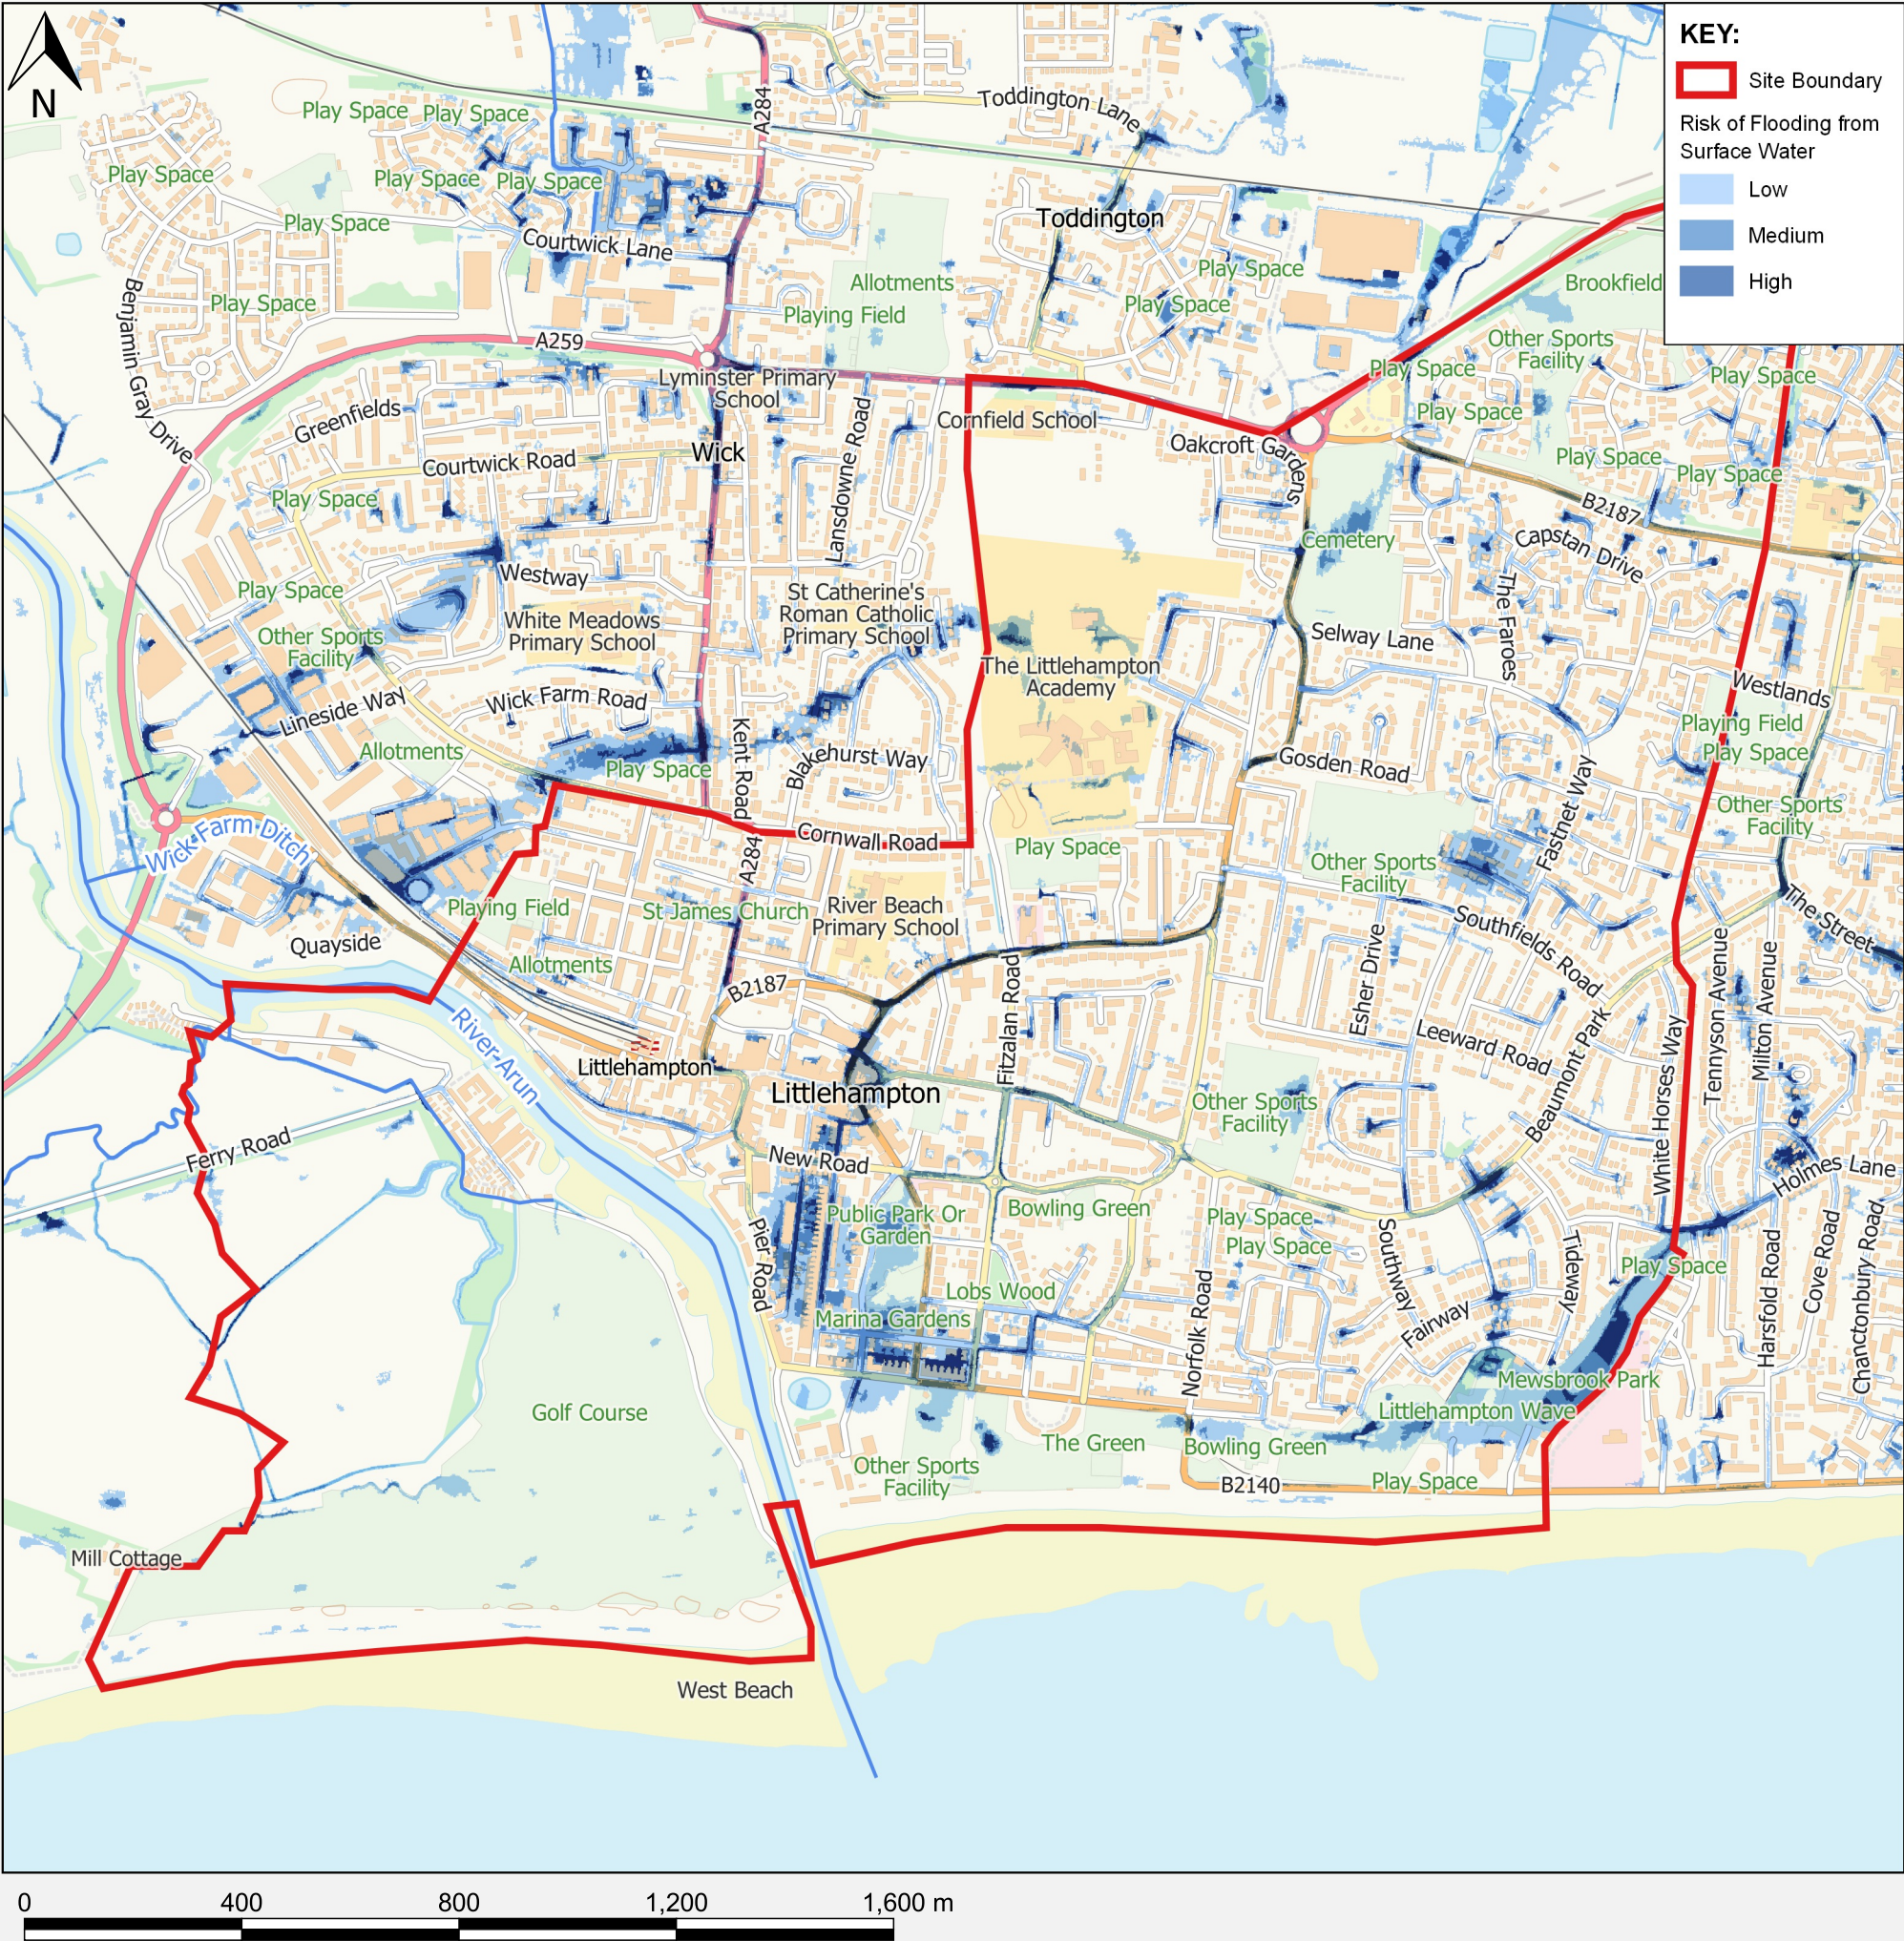
# Risk of Flooding from Reservoirs

The Risk of Flooding from Reservoirs (wet day) layer shows the individual flood extents for all large raised reservoirs in the event that they were to fail and release the water held on a "wet day" when local rivers had already overflowed their banks.

The Risk of Flooding from Reservoirs (dry day) shows flood extents for all large raised reservoirs in the event that they were to fail and release the water held on a "dry day" when local rivers are at normal levels.
