## **S19 Flood Investigation**

Storm Kathleen - Littlehampton, April 2024

Storm Kathleen, April 2024

**REPORT (VERSION1) PUBLIC**

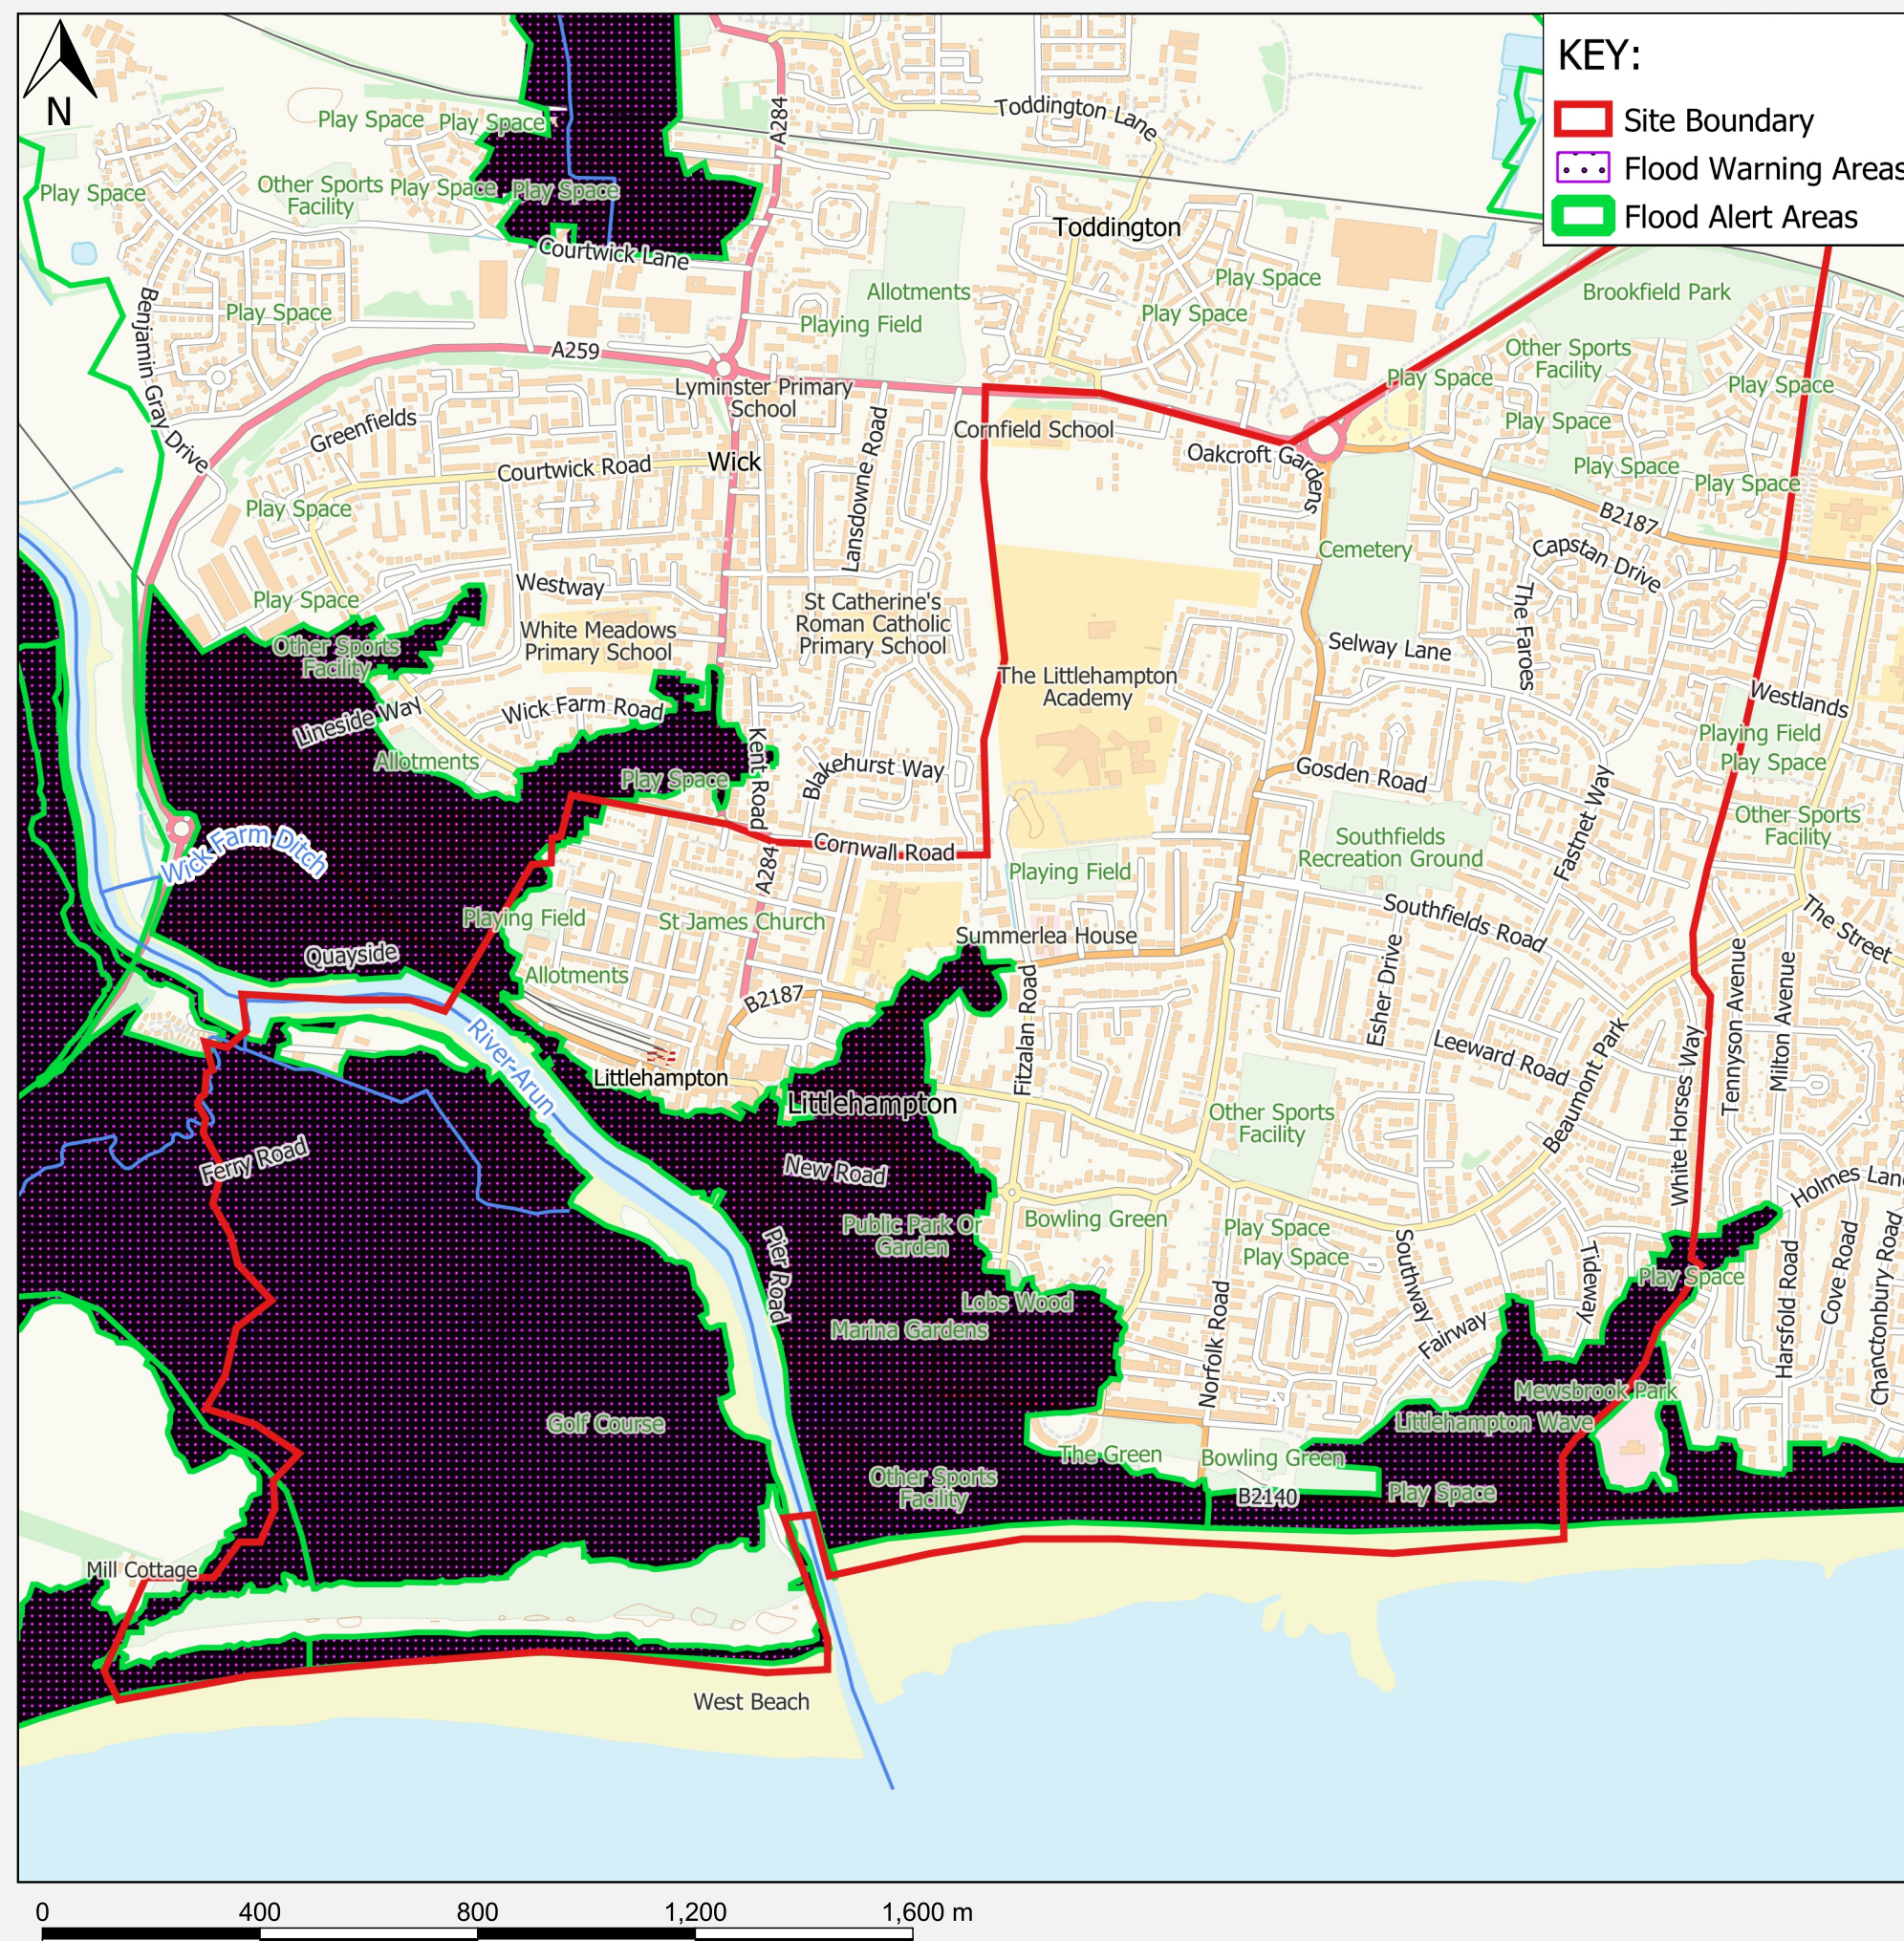
Flood Warning Areas are areas where flooding is expected to occur and where a Flood Warning Service is provided. Areas generally contain properties that are expected to flood from rivers or the sea and in some areas, from groundwater. Specifically, Flood Warning Areas define locations within the Flood Warning Service Limit that represent a discrete community at risk of flooding. The purpose of Flood Warnings is to alert people that flooding is expected, and they should take action to protect themselves and their property. Flood Warnings are issued when flooding is expected to occur, Severe Flood Warnings are issued to similar areas when there is a danger to life or widespread disruption is expected.

If an area is not covered by these layers, it does not mean that the area has never flooded, only that there are not currently records of flooding in the area.
