## **S19 Flood Investigations**

Storm Kathleen – Medmerry & Bracklesham, April 2024

# **S19 FLOOD INVESTIGATIONS**

Storm Kathleen, April 2024

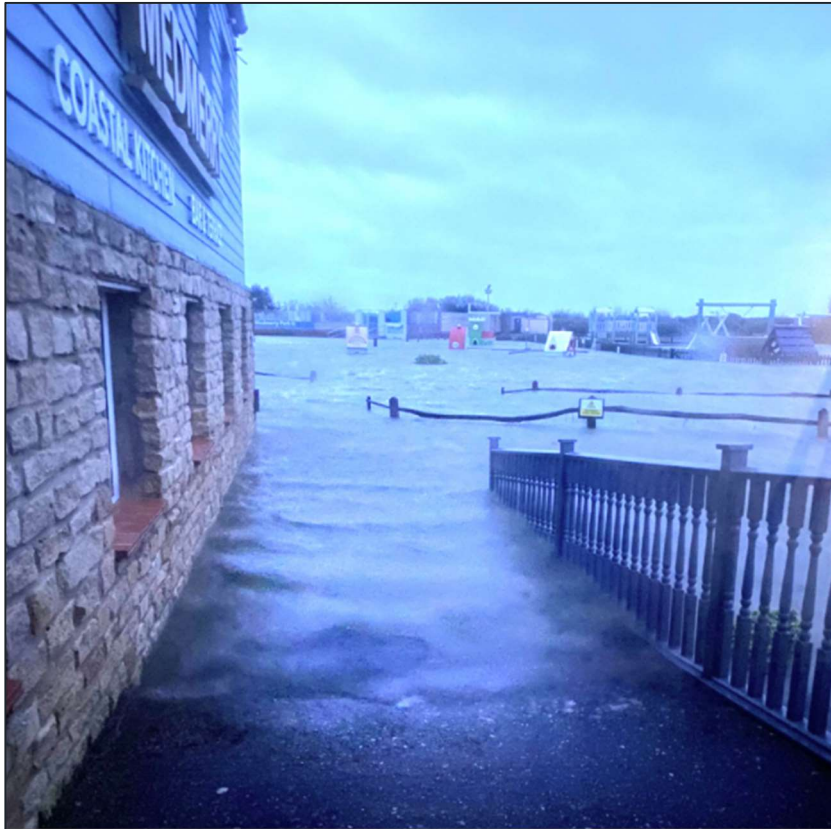
**Figure 4-4 - Flooding at Medmerry Cove Seaside Park (taken 09/04/2024)**

- 4.3.5. From interviews conducted with employees at Medmerry Cove Seaside Park, it is understood that the flooding began at approximately 12:30am on the morning of the 9<sup>th</sup> of April 2024. It occurred a few days after Storm Kathleen, which caused heavy rainfall, and during Storm Pierrick, which caused a strong tidal surge.

- 4.3.7. Employees reported that of the 268 chalets at the park, approximately 233 were flooded internally. It was also reported that a substation failed, causing a loss of power to the site. Employees began moving guests to areas of higher ground soon after the flooding started until the coastguard arrived to support evacuation from the site at approximately 3am. Approximately 150 people were evacuated to the onsite pub initially. Eventually, approximately 230 people in total were evacuated offsite. The fire and ambulance services were also reportedly in attendance during the flood event, and one person was taken to hospital suffering from exposure. The site was fully evacuated by 6am on the 9<sup>th</sup> of April.

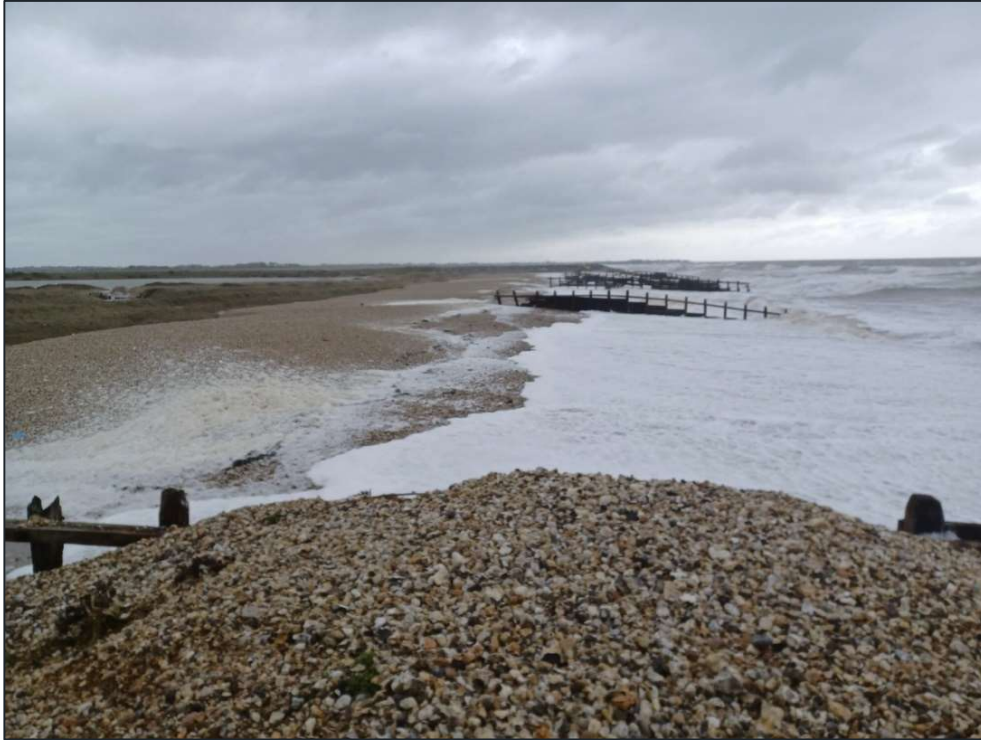
**Figure 5-4 - Environment Agency's Sea Defence at Medmerry (taken 09/04/2024)**

- 5.4.9. The strong tidal surge in April 2024 allowed seawater to overtop the defences at Medmerry West Beach, possibly causing further damage to them, and flood inland, inundating Medmerry Cove Seaside Park and the Earnley Rife which itself caused backing up of flows in the Earnley Rife which culminated in overtopping of the rife and flooding of Bracklesham Caravan & Boat Club.

- 5.4.10. Figure 5-4 below shows the condition of the defences on the morning of the 9th of April 2024, after the flood event. Figure 5-5 below shows the appearance of the defences at the time of WSP's site visit on 2nd October 2024.

- 7.3.1. The most significant recommendation of this report is that the Environment Agency could consider replenishing or upgrading their sea defences, increasing the full length of defence to a level matching or exceeding the adjoining CDC defences to the west, thereby increasing the level of protection currently afforded to both sites.
- 7.3.2. Furthermore, it is recommended that the Agency could investigate the reason for the removal of the flap valve that is believed to previously have been in place along the Earnley Rife (refer to Section 5.5). The Environment Agency could consider reinstating the flap valve to prevent surcharging of flows in the rife, as was seen in April 2024. Modelling may be required to ensure that mounting a

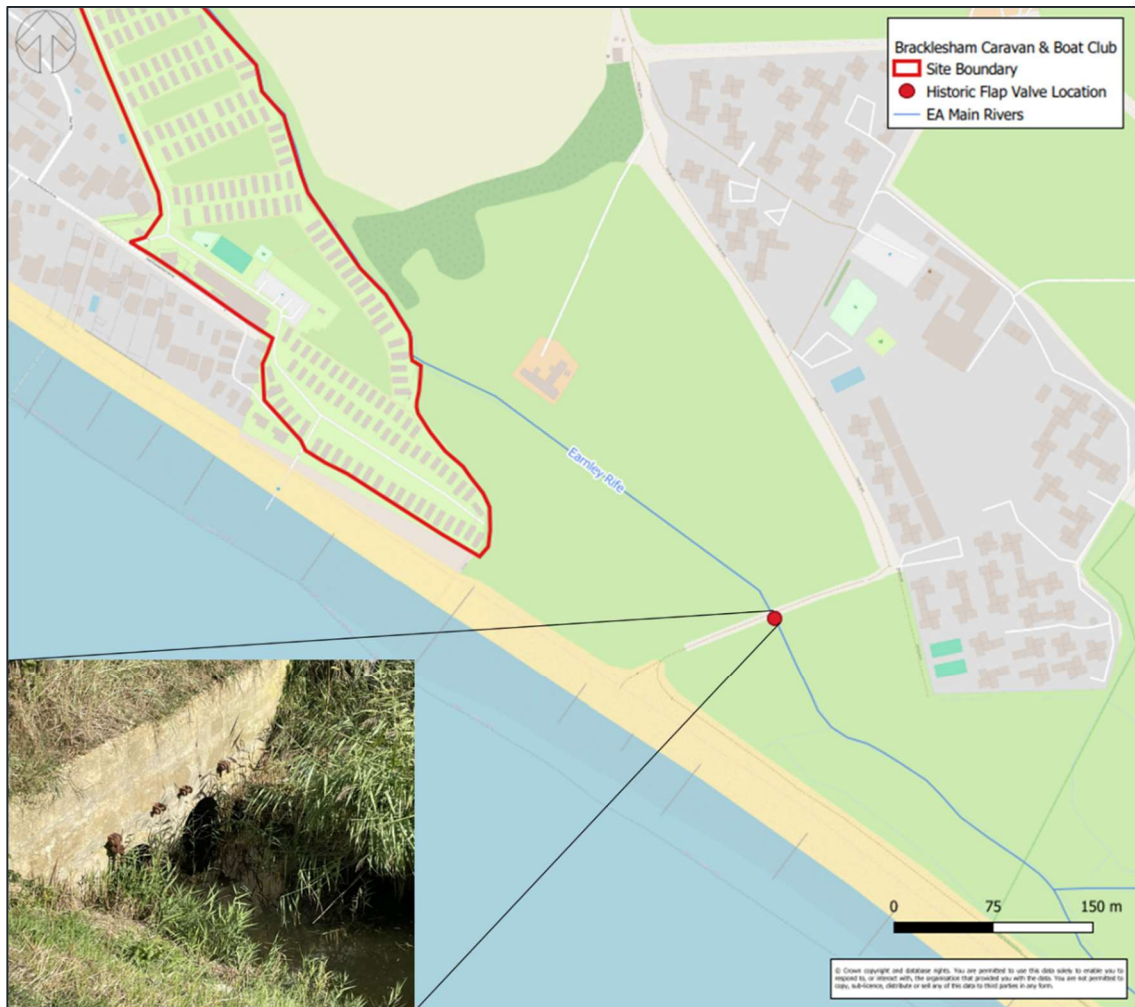
**Figure 5-6 – Earnley Rife Culvert Location (note flap valve mountings on inset image)**

- 5.5.1. During WSP's site visit to Bracklesham it was noted that one of the culverts conveying the Earnley Rife below an access track to the south of Medmerry Sea Cove Park had mounting points for a flap valve. This suggests that a flap valve was previously fixed to the headwall to prevent water backing up the Earnley Rife in the event of seawater inundating the rife further downstream. Refer to Figure 5-6. The reason for the absence of the flap valve is not known, however it could have contributed to the flooding of Bracklesham Caravan and Boat Club.

- 7.3.3. The Environment Agency could conduct a topographic and condition survey of the Earnley Rife to better understand the levels along the watercourse. This could lead to better maintenance of the rife and inform concepts for flood alleviation within its catchment.
- 7.3.4. Consultation with the Environment Agency has confirmed that a combination of water level and half nearshore wave height is used to trigger their flood alerts and warnings. A height exceeding 4m will trigger a flood alert and a height exceeding 5.2m will trigger a flood warning. The Environment Agency could consider lowering these trigger values to better represent the status of the coastal defences at Medmerry West Beach. This would allow more time for preparation and evacuation for those at risk of flooding.

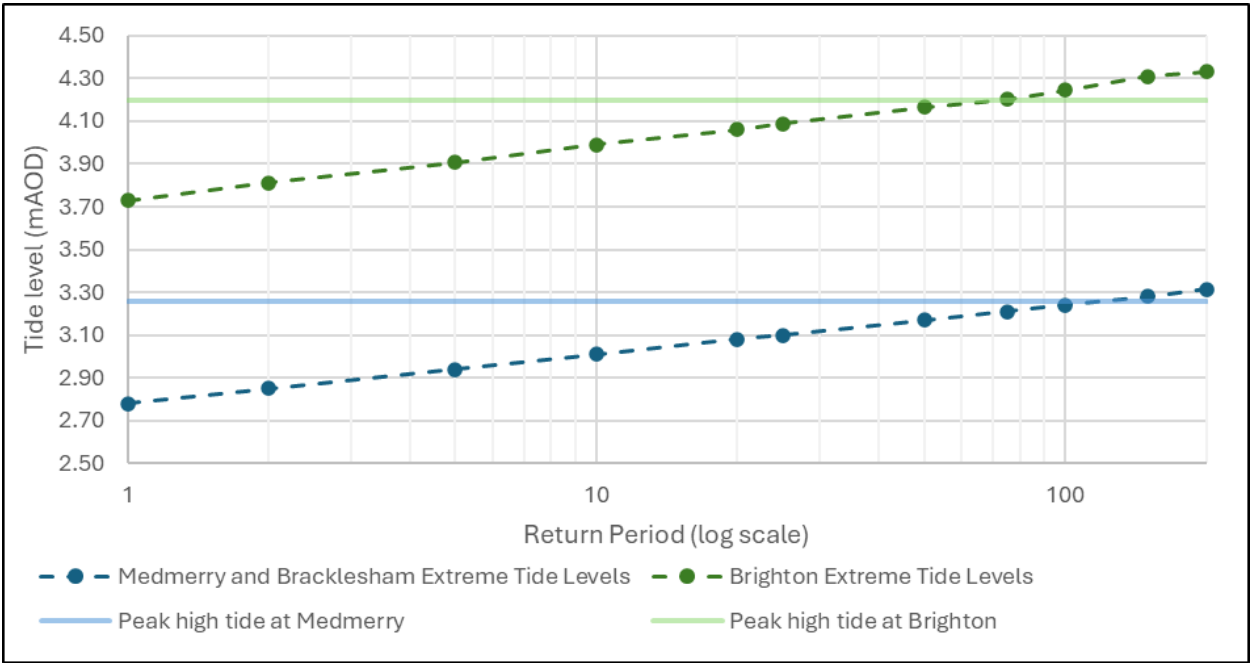
Figure 4 - Comparison of recorded peak high tide on 9th April at Medmerry (blue) and Brighton (green) against the extreme water level return periods obtained from the Environment Agency dataset.

Figure 4 demonstrates that the peak high tide of 3.26 mAOD experienced at Medmerry is estimated equivalent to a return period of a 1-in-100-year tide according to an average of the Environment Agency’s Coastal Flood Boundary Dataset points along the coast at Medmerry and Bracklesham. Similarly, at Brighton, the experienced peak high tide of 4.19 mAOD is estimated equivalent to the average 1-in-75-year tide along the coast at Brighton.
